2016 BRIDGE INSPECTION REPORT

ROUTE 58 BUSINESS (RIVER STREET)
OVER
FALL CREEK

STRUCTURE NUMBER: 1901

STRUCTURE INSPECTION REPORT – REGULAR

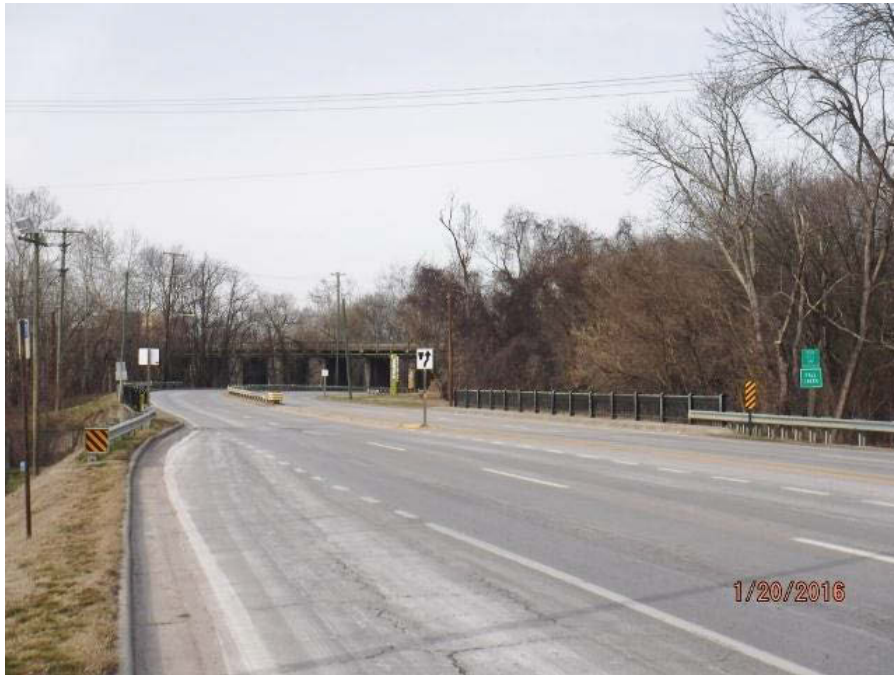
PHOTO #1

Approach elevation looking from Abutment A to Abutment B.

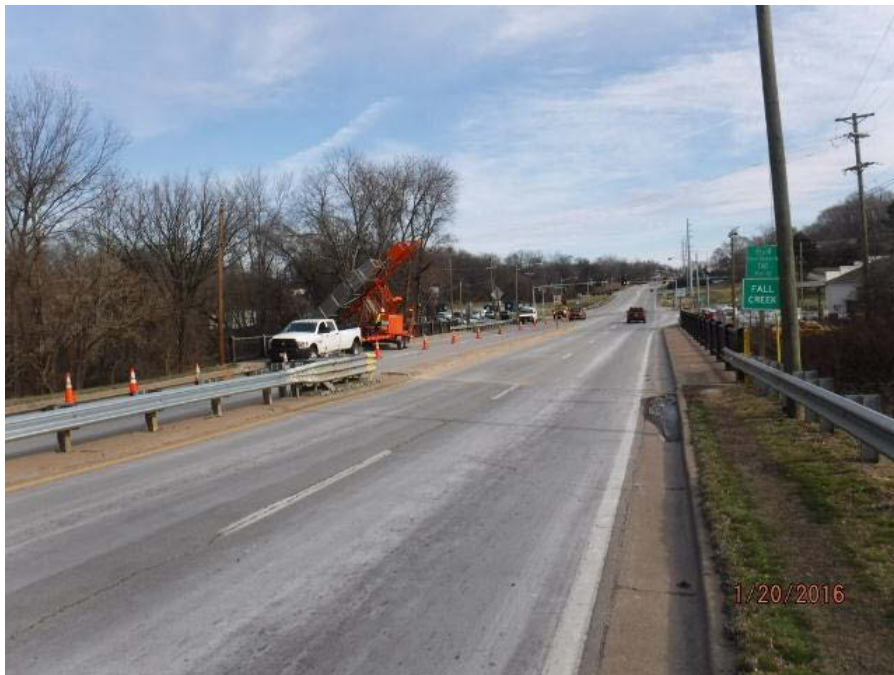
PHOTO #2

Approach elevation looking from Abutment B to Abutment A.

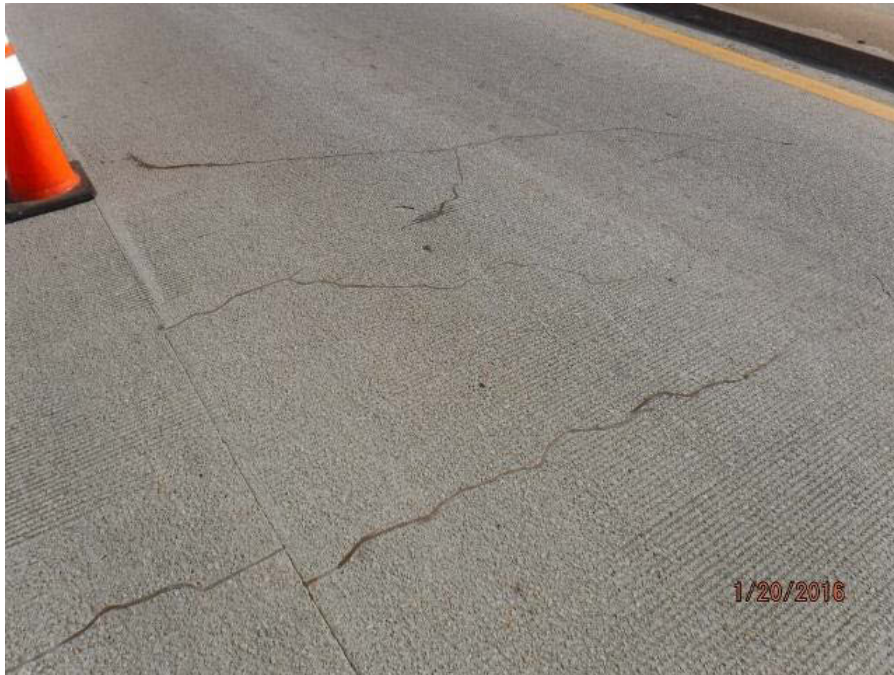
PHOTO #7

Wearing surface has hairline diagonal and transverse cracks as follows:

Lane		Span 1 (LF)	Span 2 (LF)	Span 3 (LF)
EBL	sealed	55	100	75
	unsealed	10	20	10
WBL	sealed	40	170	100
	unsealed	5	25	25

Sealed cracks in wearing surface, westbound lane, Span 2. Note scale.

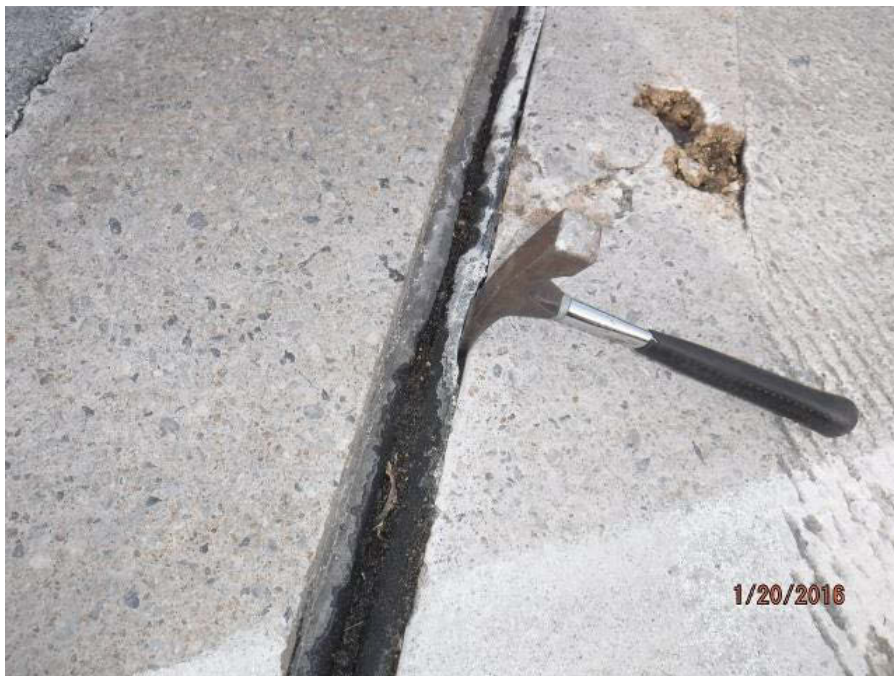
PHOTO #8

★Wearing Surface has light scale with aggregate polishing over 30% of entire surface.
See Photo #8.

★Expansion dam at Abutment B, right lane of EBL has 1 SF spalled concrete 1" deep.
See Photo #8.

<u>Railing (Cont'd.)</u>	<p>Several railing connection bolts at cantilevered connections on both sides of structure have severe corrosion and up to 30% section loss.</p> <p>★ Railing post at Abutment B is twisted 3/4" x full height with one flange bent 3/4" x 9".</p> <p>★ 4th Railing post from Abutment A has previous corrosion with 75% section loss on lower 4" with a 2" X 4" corrosion hole at connection to bracket support. See Photo #10.</p>
<u>Drains</u>	★ Two (2) scuppers on the upstream side are clogged.
<u>Utilities</u>	<p>Waterline bowed up 1' above support located 10' from Abutment A in Bay 1. See Photo #11</p> <p>Waterline at Abutment A encroachment has heavy corrosion and 1/8" pitting on bottom. See Photo #12.</p> <p>Waterline support in Bay 1 of Span 2 at Pier 1 is failing (sagging) due to severe section loss in web of channel. Large corrosion holes are present.</p>
<u>Expansion Joints</u>	<p>Expansion joints are partially filled with dirt and debris.</p> <p>★ Expansion joint material is leaking at Abutment A EBL for 3 LF and Abutment B EBL for 3 LF. See Photo #8.</p>

Spalled concrete in expansion dam and leaking expansion joint at Abutment B.

RECOMMENDATIONS	-Repair bearing assemblies that have gaps between bearing device and beam. -Replace leaking expansion joints. -Replace failed waterline support in Bay 1 at Pier 1. RECOMMENDATIONS continues on next page.

- Clean, prepare and paint structural steel and railing.
- Repave approach pavement.
- Repair spalled expansion dam at Abutment B.
- Repair delaminated/spalled concrete in bottom of deck, overhang, and substructure.
- Replace corroded and damaged rail posts and corroded railing bolts.
- Replace missing anchor bolts/nuts in bearing devices.
- Replace damaged approach guardrail.
- Clean clogged deck drains.

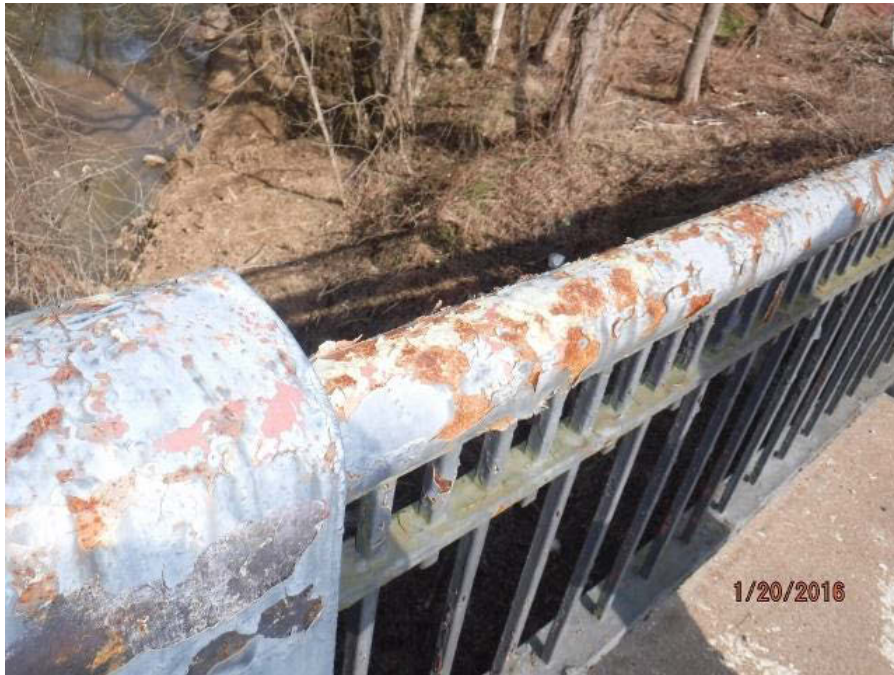
RailingRailing has peeling paint throughout. **See Photo #9.**

PHOTO #9
Peeling paint on railing.

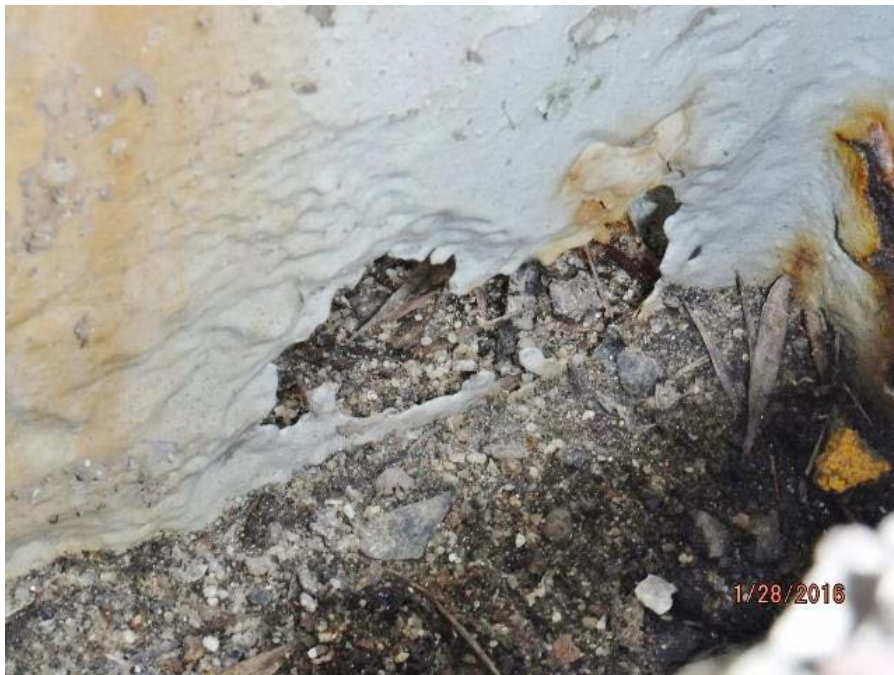
PHOTO #10
Corrosion on 4th railing post from Abutment A.

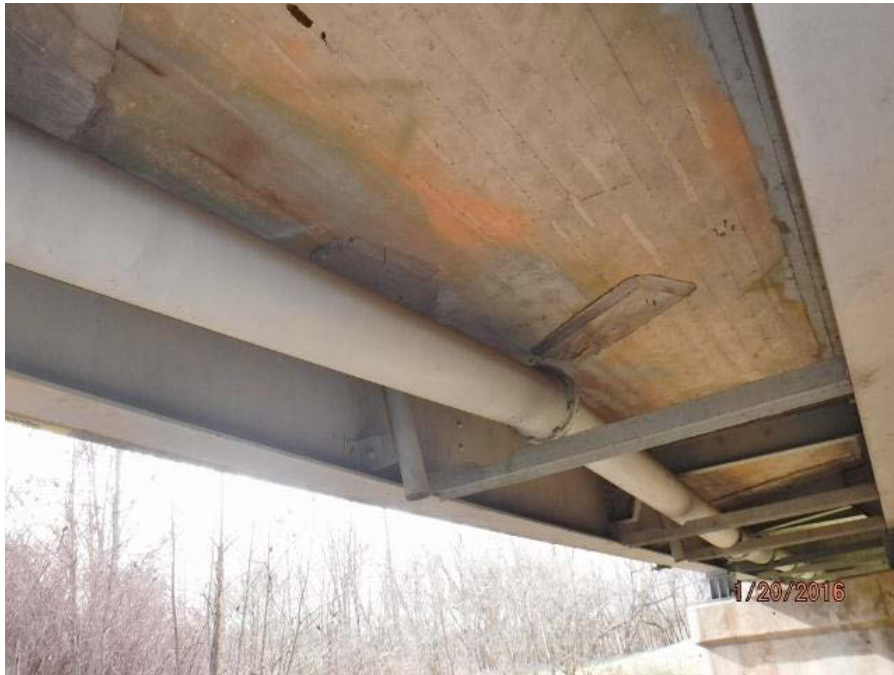
PHOTO #11
Waterline is bowed above support, Bay 1.

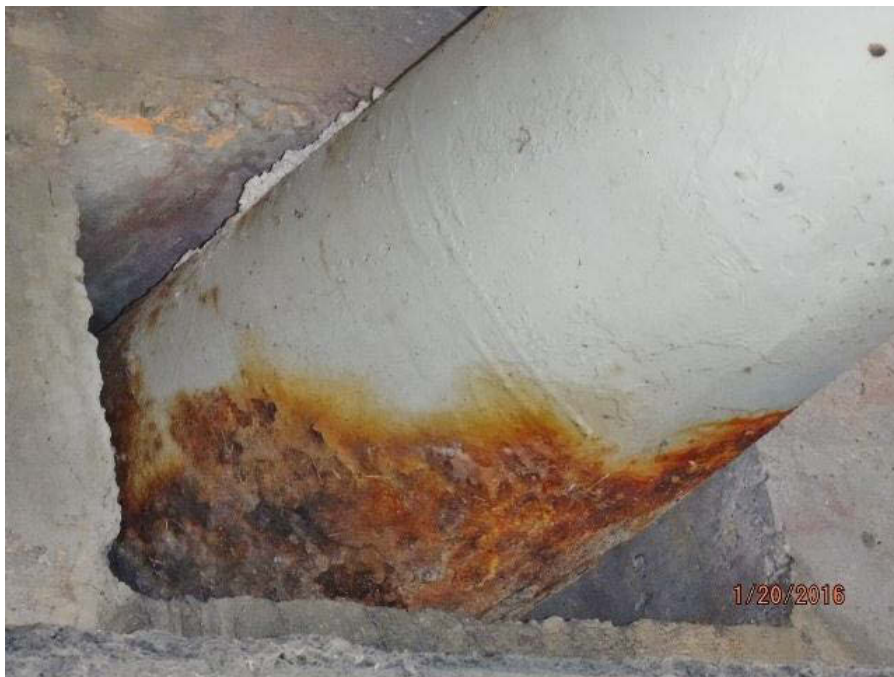
PHOTO #12
Corrosion and pitting in waterline, Abutment A.

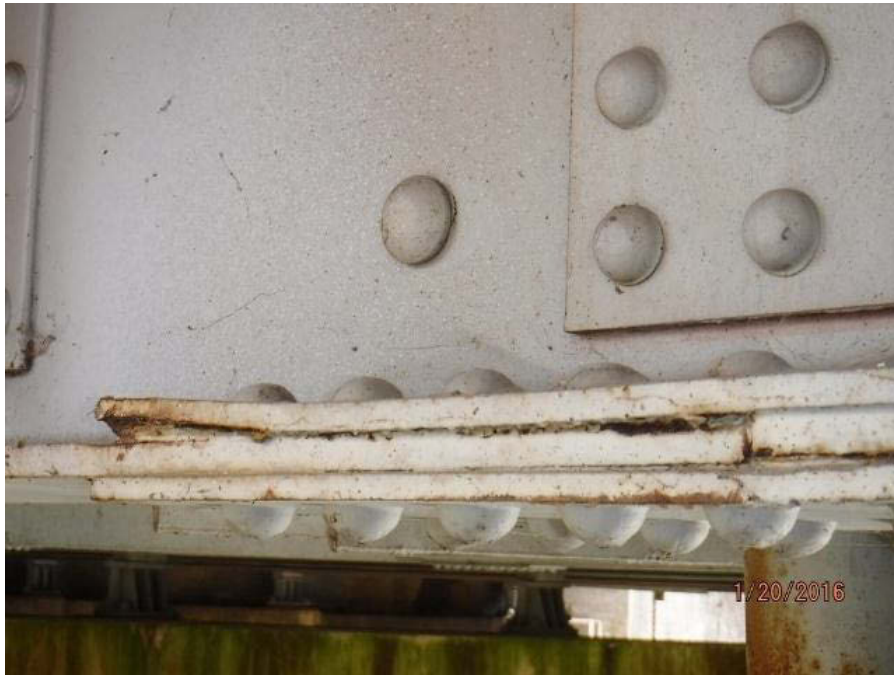
PHOTO #13
Pack Rust on Beam 8 splice.

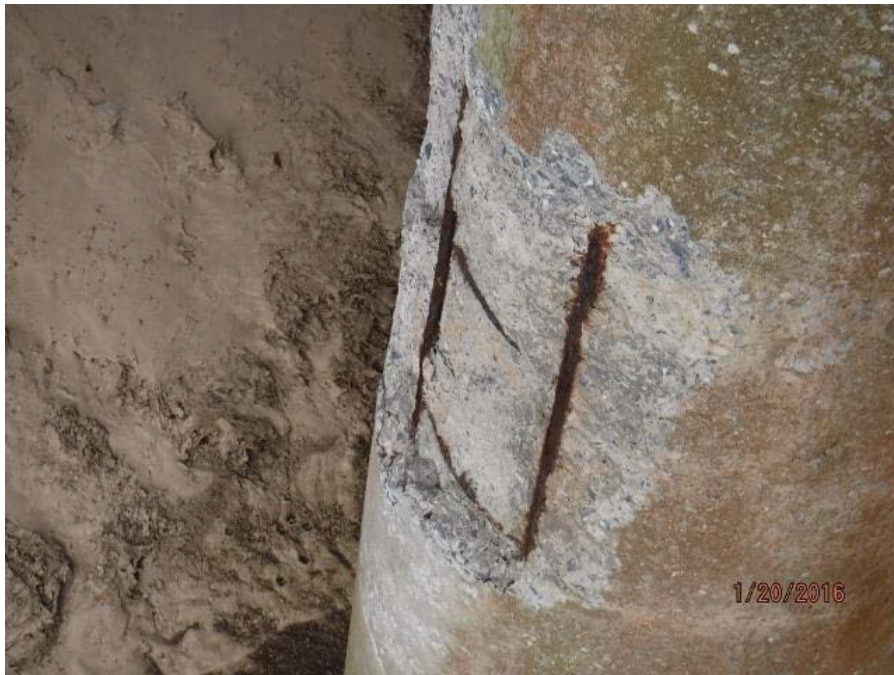
PHOTO #14
Spalled concrete on Pier 1 wall, upstream end.

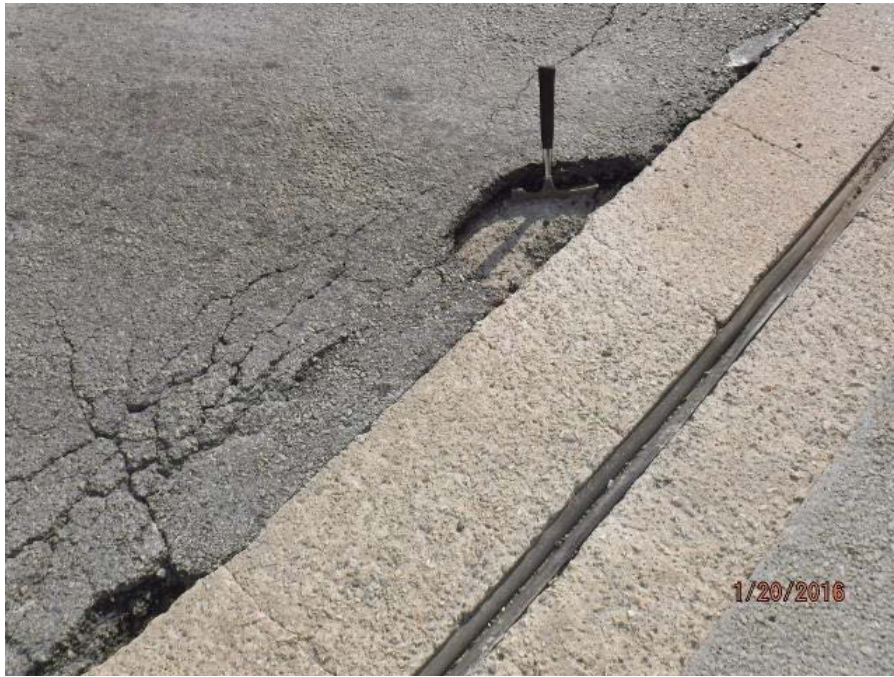
PHOTO #15

OTHER	
APPROACH PAVEMENT	Approach pavement at Abutment A is cracked 1/4" wide and breaking up for 20 SF adjacent to backwall with 4 SF of potholes (2" deep). See Photo #15. ★ Approach pavement at Abutment B is cracked 1/4" wide and breaking up for 30 SF ★ Approach median is 3" low at Abutment B.
TRAFFIC SAFETY FEATURES	
<u>Bridge Railing</u>	Substandard.
<u>Transitions</u>	Substandard.
<u>Approach Guardrail</u>	Substandard. ★ Approach guardrail on upstream side of Abutment A has 20 LF of impact damage.
<u>Approach Guardrail Terminal</u>	Substandard.
OBJECT MARKERS	Object markers (Type 3) in place at Abutment A (WBL) run-on end of structure on upstream side.

Approach pavement at Abutment A is cracked, breaking up and has potholes.

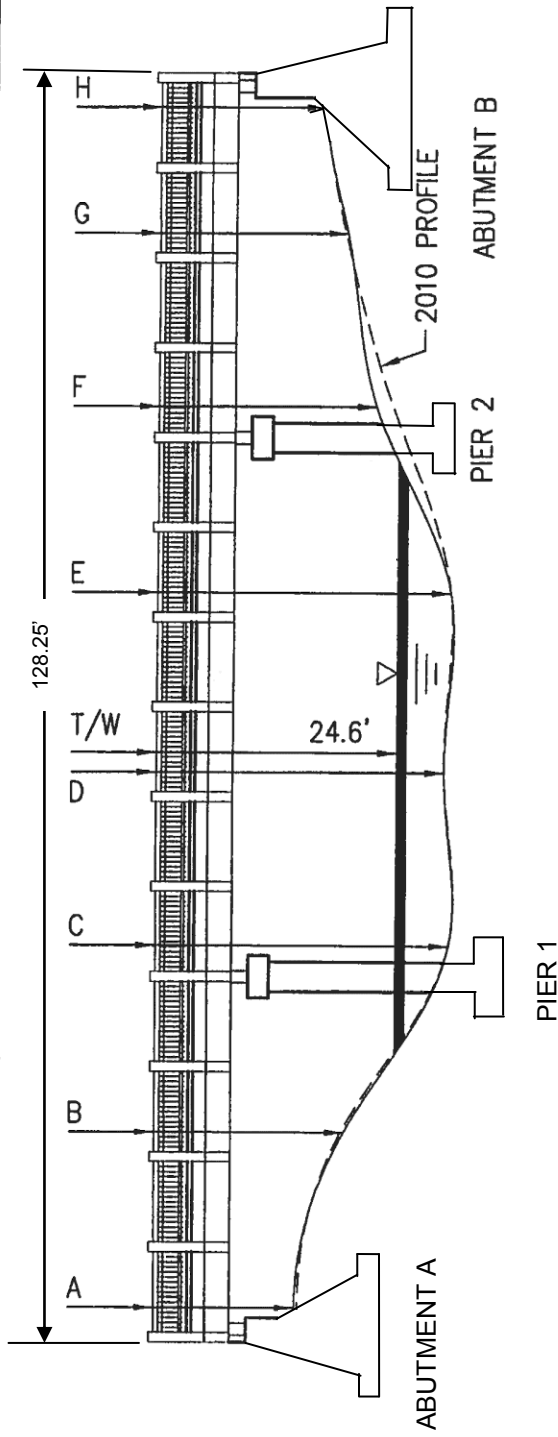
UPSTREAM PROFILE - ROUTE 58 BUS.
(RIVER STREET) OVER FALL CREEK

CHANNEL AND SLOPE PROTECTION	Condition Rating: 7
<u>Channel</u>	Channel Profile checked this inspection and no significant change found since 01/27/2010. See attached channel profile sketch.
<u>Scour</u>	No deficiencies found.
<u>Embankment Erosion</u>	No deficiencies found.

Checked 2016 - No significant changes
JBH

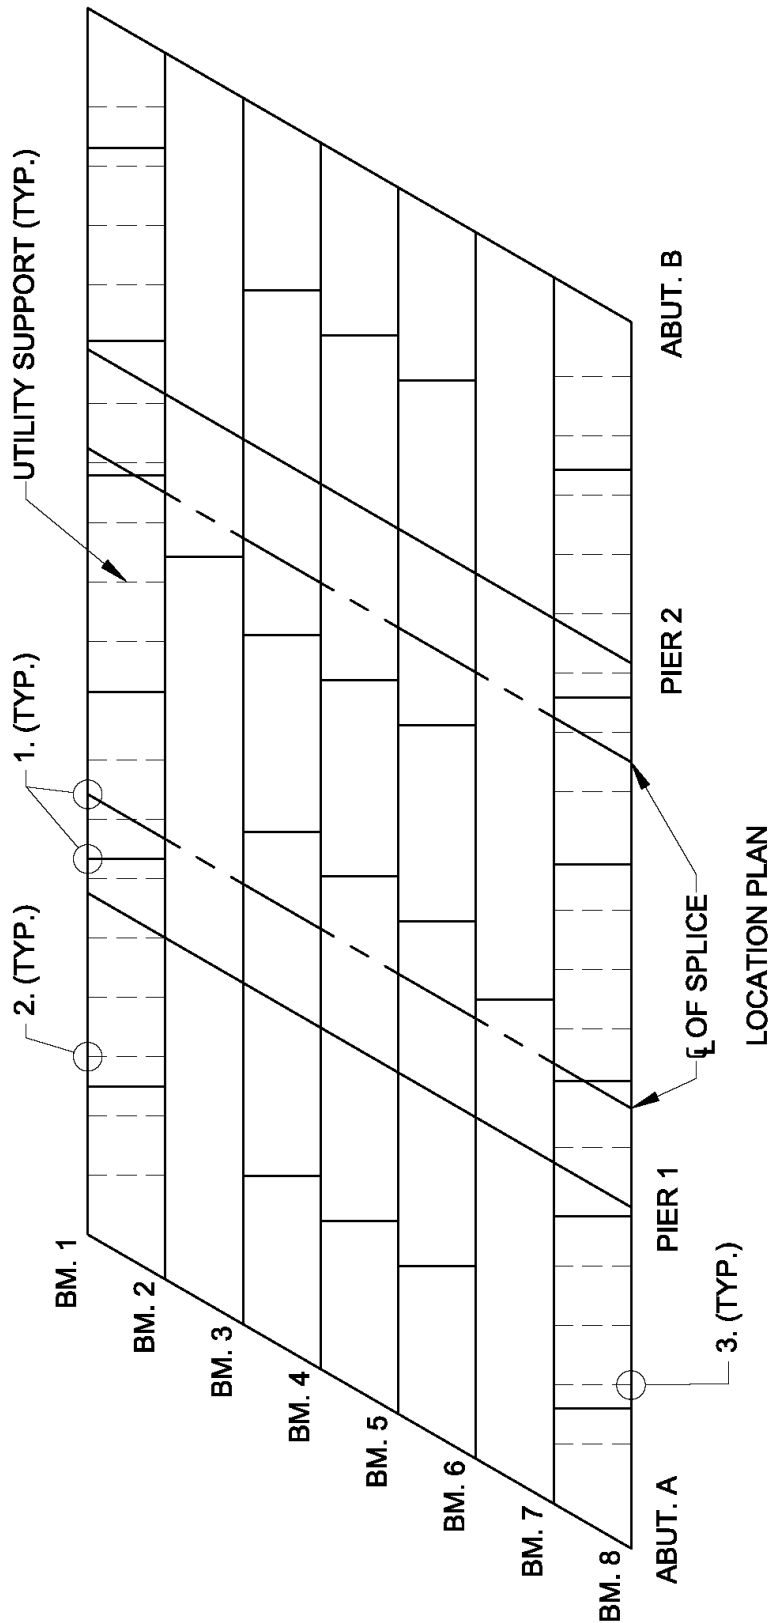
Fatigue Prone Details

1. CATEGORY D
ALL RIVETED CONNECTIONS

2. CATEGORY E
UTILITY SUPPORT -
FILLET WELD TO
WEB OF BEAM

3. CATEGORY C'
UTILITY SUPPORT -
FLANGE-TO-FLANGE
FILLET WELD
